THE HANFORD SITE

Hanford Double-Shell Tank Tank Integrity Program Update

Dusty Stewart (ORP)
Karthik Subramanian (WRPS)

January 8, 2020

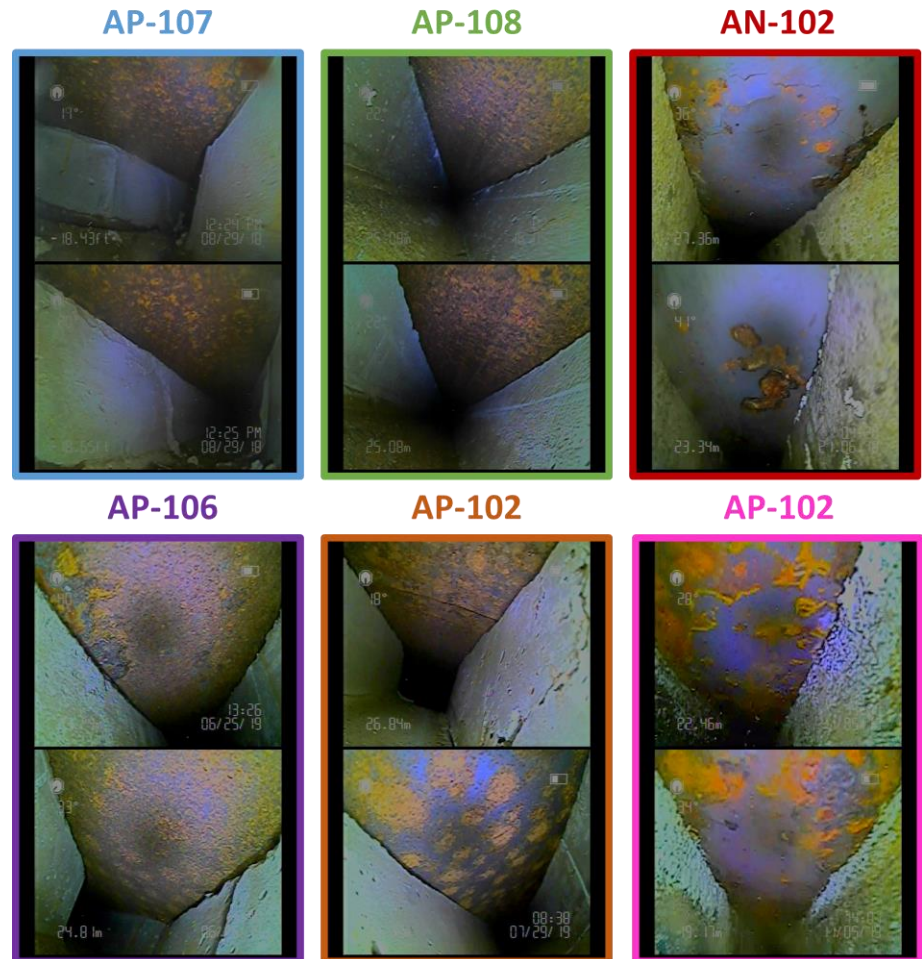
Push-Pull arm system attached to existing inspection crawler platform deploys rigid tethered inspection camera with pan/tilt functionality
